TWINGO

8 Electrical equipment

86A RADIO

R2-08

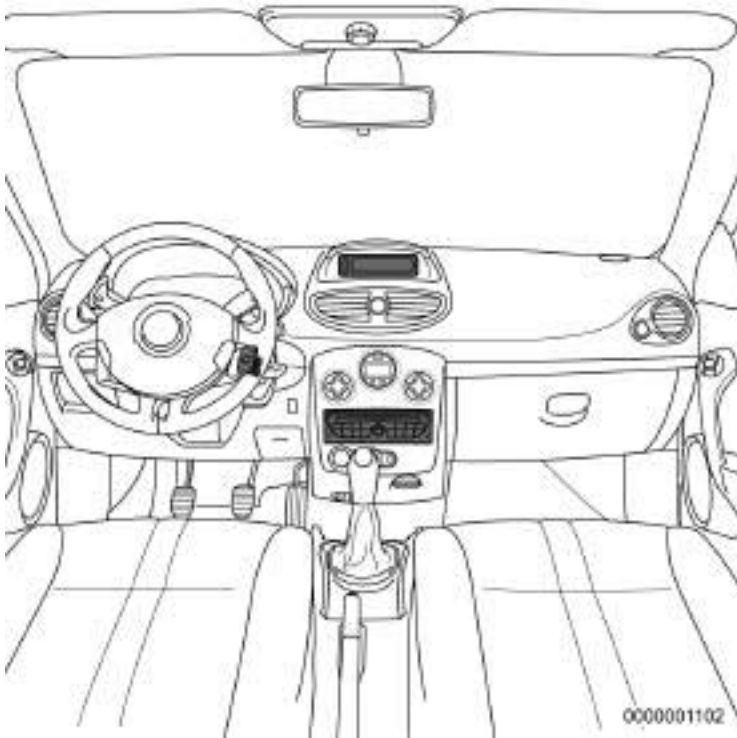
Location of components in the passenger compartment

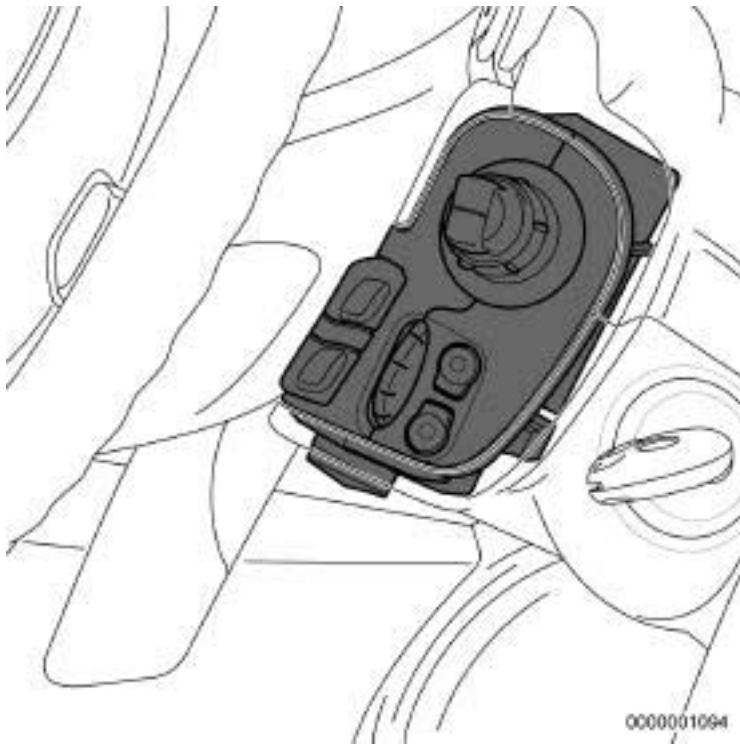
Radio control satellite

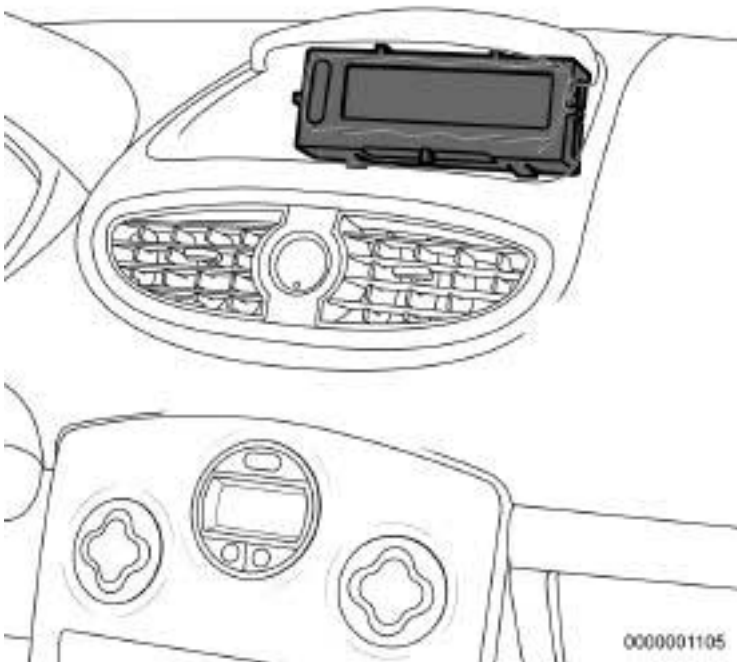
Display

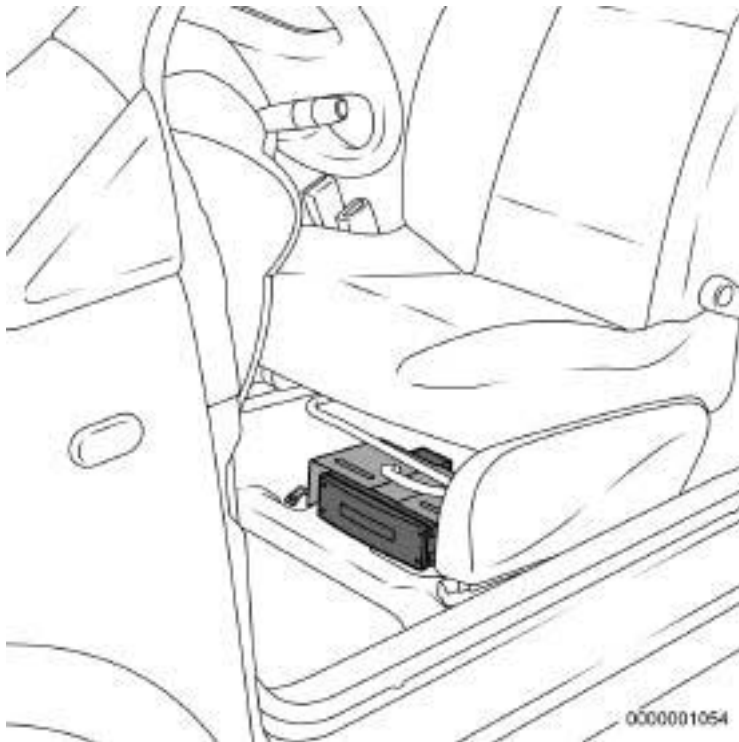
CD changer

Check for a CD changer in the vehicle.
Check the consistency between the configuration of the radio and the vehicle equipment by reading configuration LC005 External components and correct it, if necessary, using SC002 Computer configuration (see Configuration and programming).
If the vehicle is equipped with a CD changer, it was fitted as an accessory. Please refer to the handbook delivered with the product.
If the fault is still present, replace the CD changer.

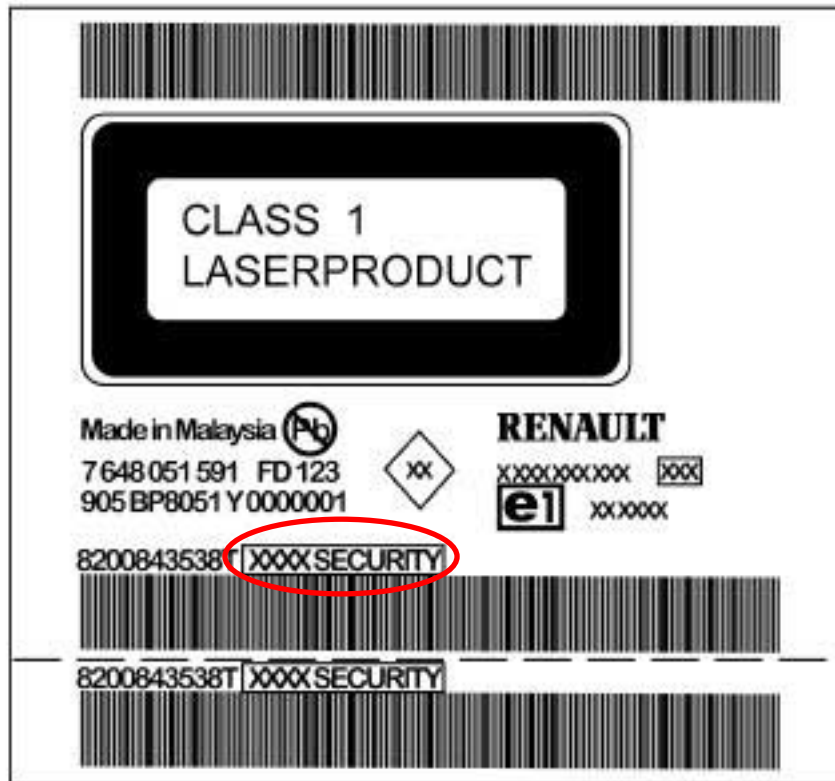
The pre-code is recovered by consulting **ID007 Radio programming key** using the **diagnostic tool** or by removing the radio and noting the four characters on the barcode following the letter **T** (see photo below).

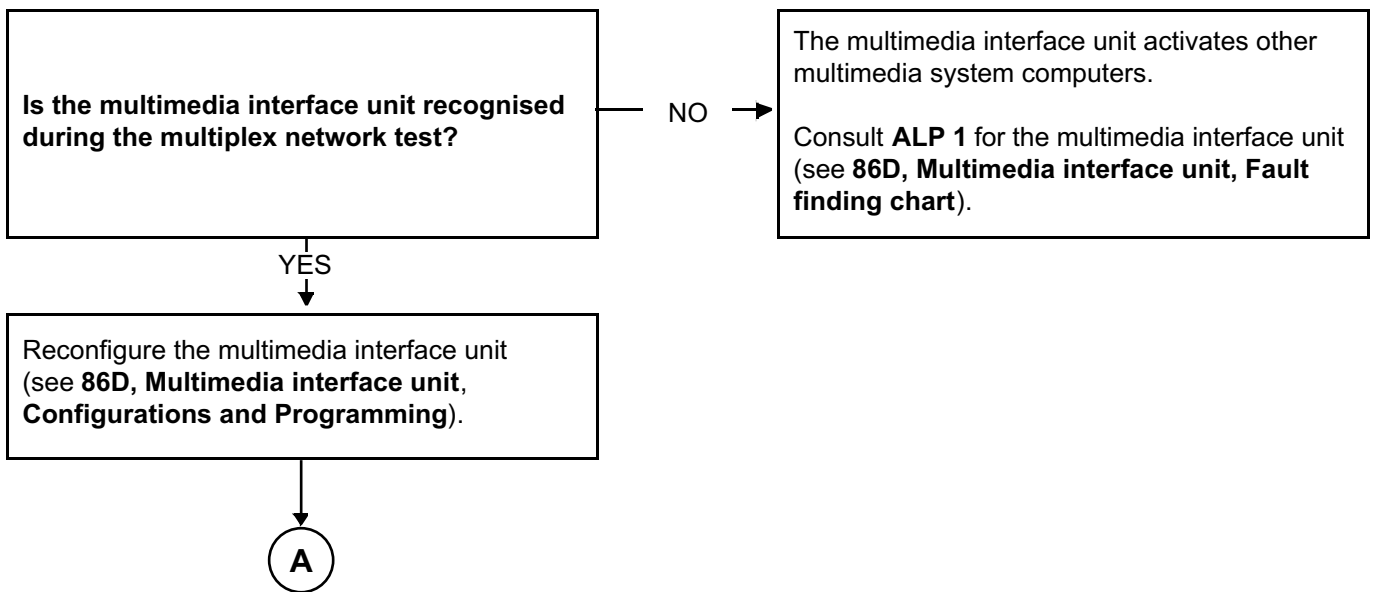
ALP 1	No dialogue with the computer
--------------	--------------------------------------

NOTES	<p>Try to establish dialogue with a computer on another vehicle to check that the diagnostic tool is not faulty. If the diagnostic tool is not causing the fault and dialogue cannot be established with any other computer on the same vehicle, it may be that a faulty computer is disrupting the fault finding line. Use a process of successive disconnections to locate this computer. Check the battery voltage, component code 107, and perform the necessary operations to obtain the correct voltage (12 V < X < 15 V).</p>
	<p>Ensure that the communication conditions are met: + After ignition feed activated and radio On/Off button pressed.</p>
	<p>Use the Wiring Diagrams Technical Note for Clio III or New Twingo.</p>
	<p>For a vehicle equipped with a Navigation computer, use component 1714, Multimedia connection unit, for fault finding on the Multimedia interface unit. Otherwise use component 653, display computer.</p>

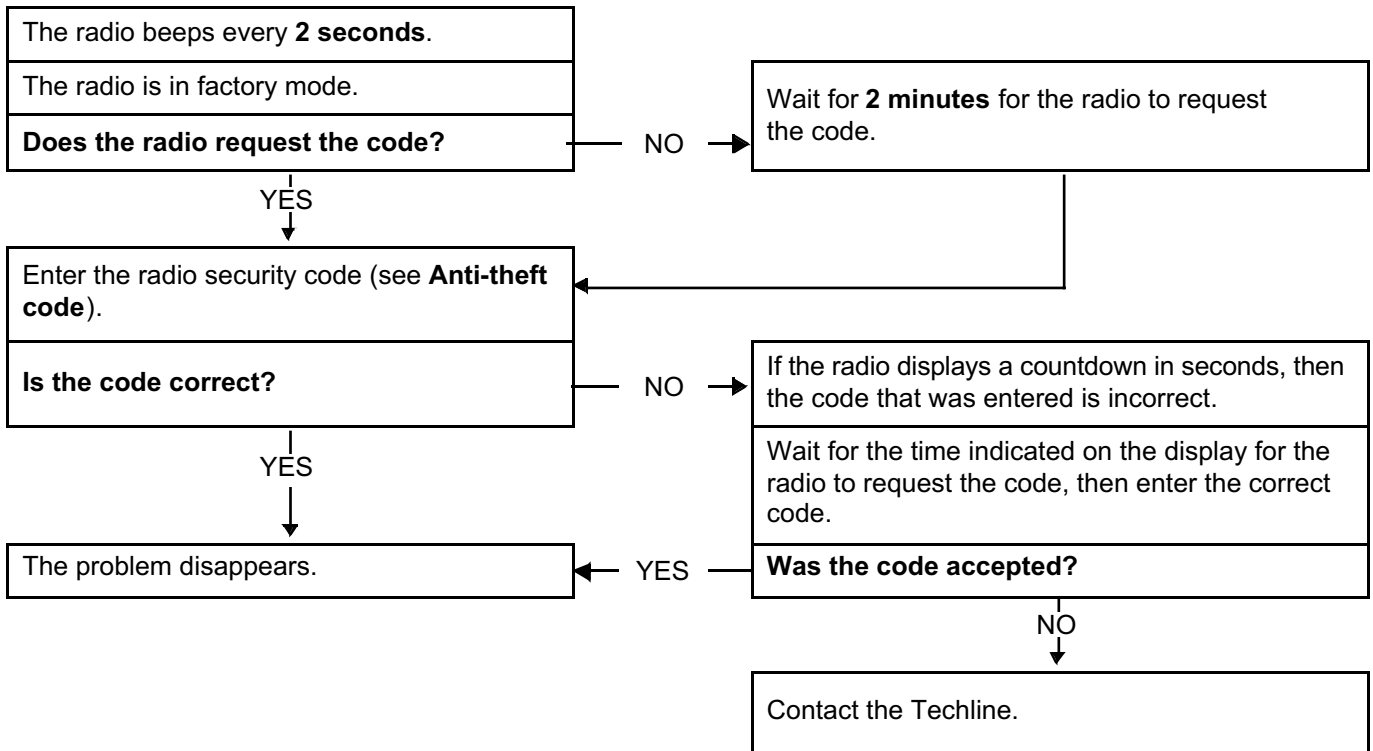
ALP 2	The radio beeps every 2 seconds
--------------	--

NOTES	Use the Wiring Diagrams Technical Note for Clio III or New Twingo .
--------------	--

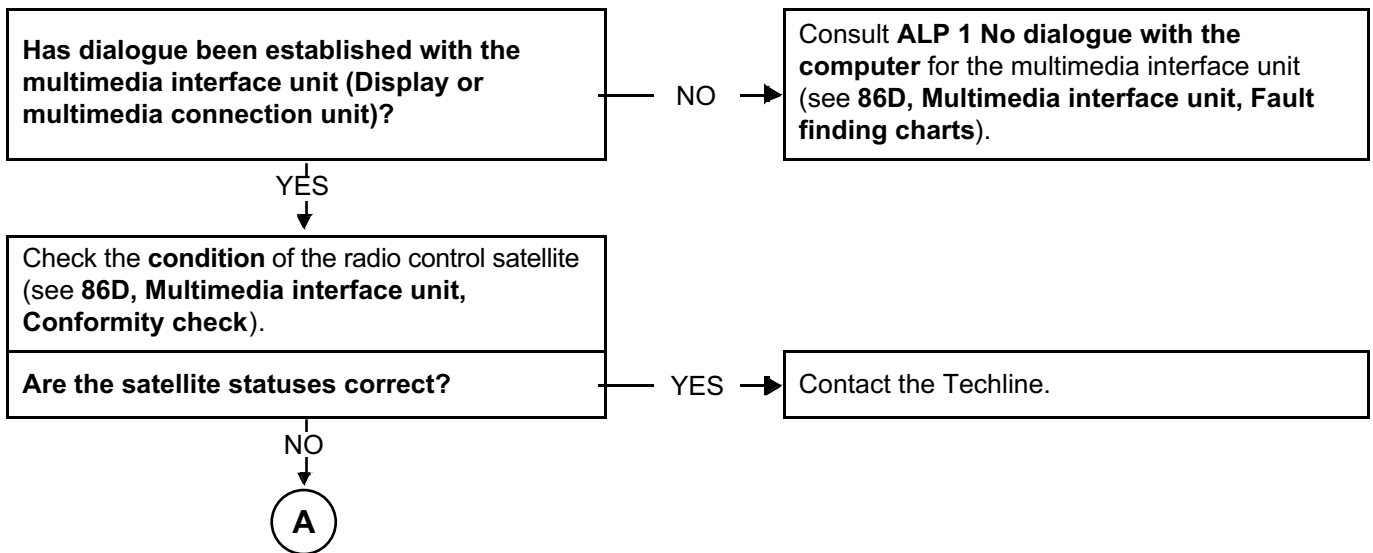
ALP 5	The radio control satellite does not operate or operates poorly
--------------	--

NOTES	Use the Wiring Diagrams Technical Note for Clio III or New Twingo .
--------------	--

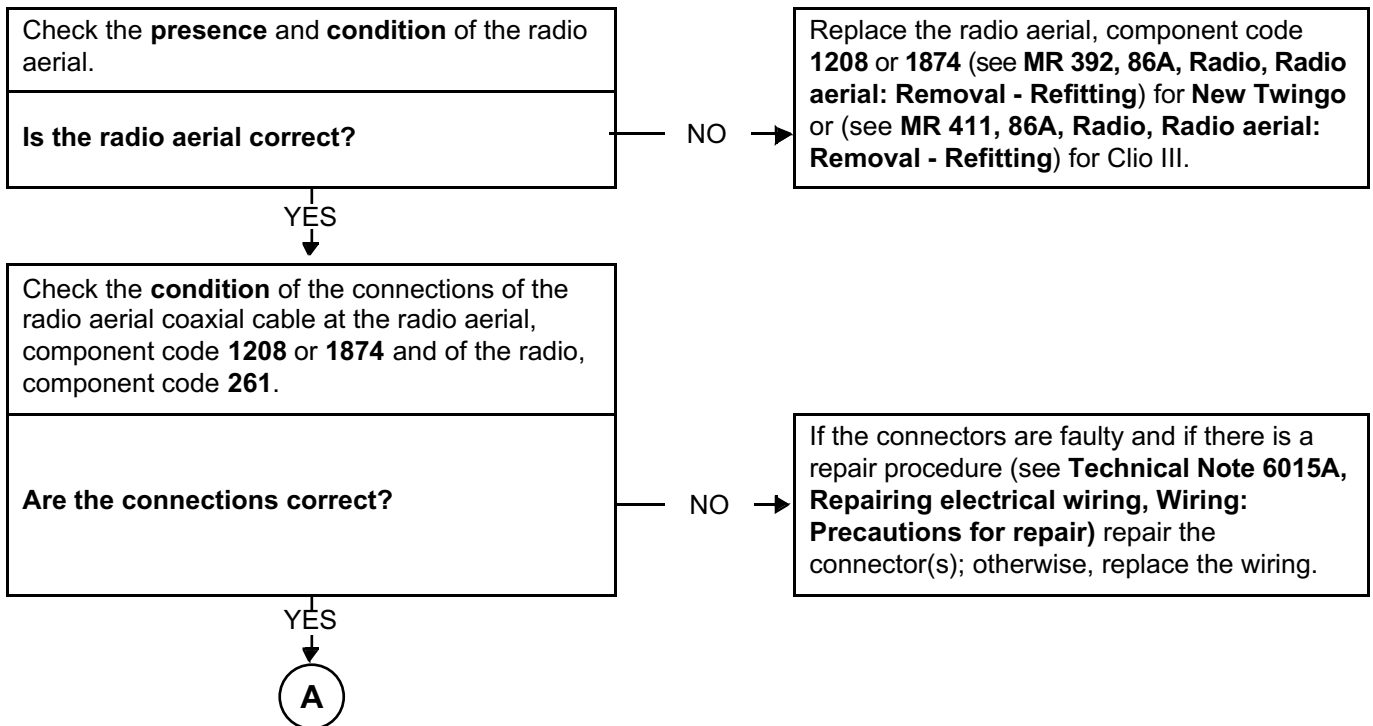
ALP 6	Radio reception fault.
--------------	-------------------------------

NOTES	See Clio III or New Twingo wiring diagrams.
	For the aerial, use component code 1874 for a vehicle equipped with a navigation system, and 1208 for a vehicle without this option.

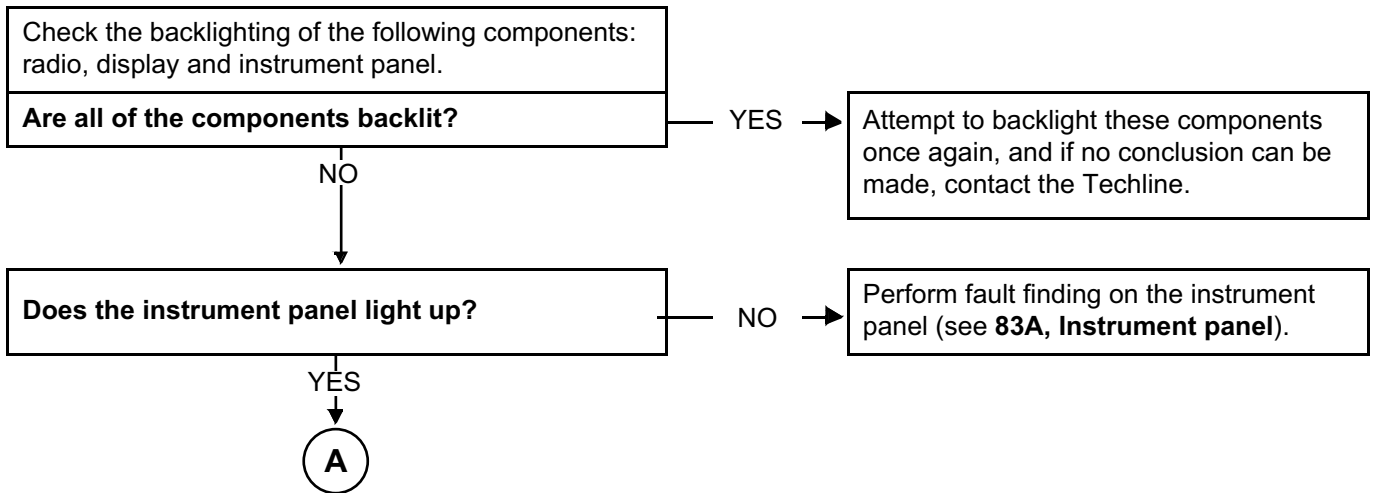
ALP 8	Backlighting does not change when the vehicle lights are switched on
--------------	---

NOTES	Use the Wiring Diagrams Technical Note for Clio III or New Twingo .
	NOTE: Switch on the side lights and position the lighting rheostat wheel in the centre position.
	The display, component code 653 , is only available when the vehicle does not have the navigation function. The multimedia connection unit, component code 1714 , is only available when the vehicle has the navigation function.

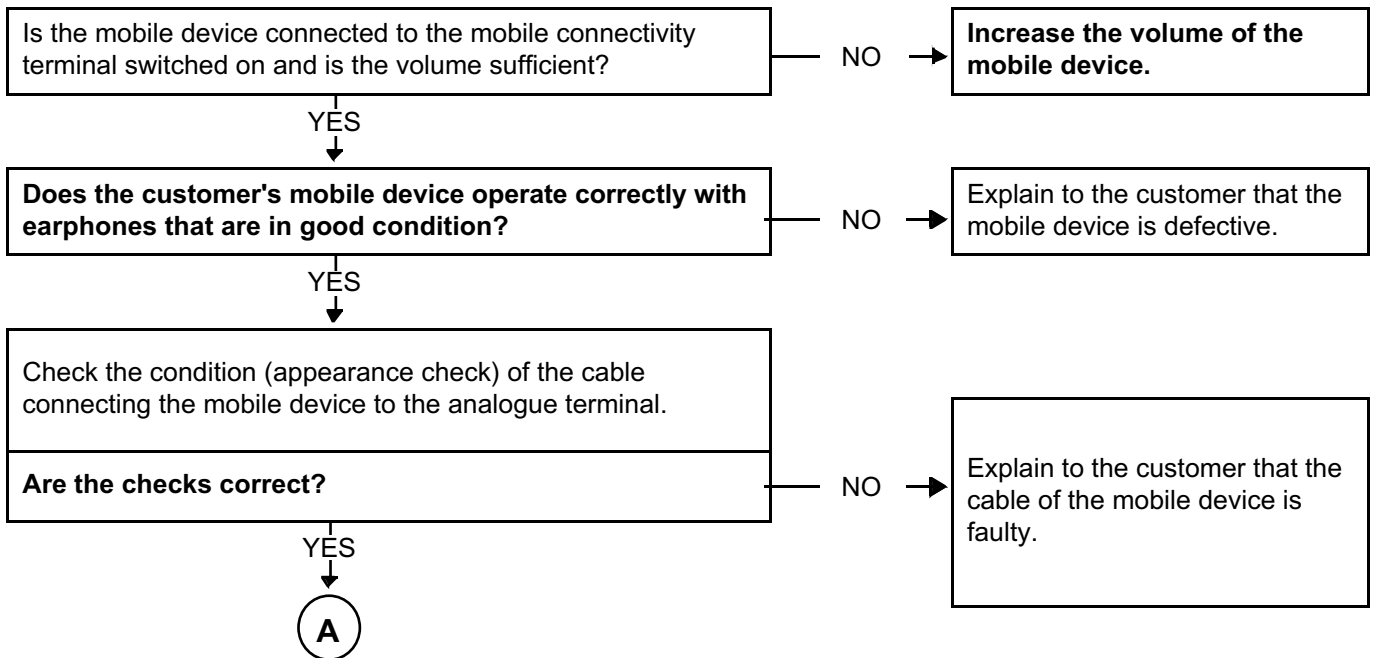
ALP 18	Fault when using the mobile connectivity terminal
---------------	--

NOTES	See Clio III or New Twingo wiring diagrams .
	ALP 18 is used to run fault finding on the mobile connectivity terminal if a mobile connectivity computer is not fitted on the vehicle.
	In a vehicle equipped with a navigation computer, the terminal is connected to the navigation computer, component code 662 . Otherwise, it is connected to the radio, component code 261 .
